# NHS WALES

## Estates and Facilities Notice

Reference: EFN2501

## GS Yuasa SWL1100FR Lead Acid Battery: reports of smoking and electrical fires in UPS systems

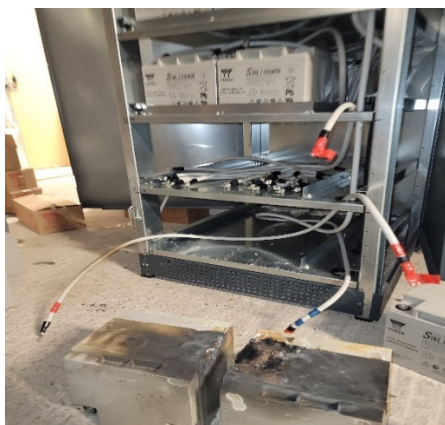
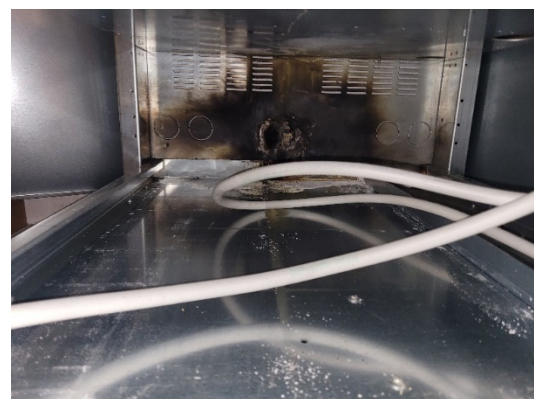
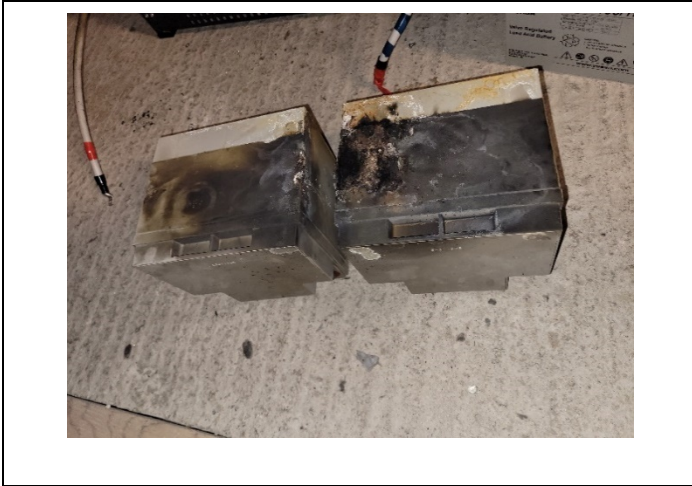
GS Yuasa were made aware that a small number of UK manufactured SWL1100FR lead acid batteries were found with a fissure on the corner of the battery container. Electrolyte leakage via this fissure results in localised corrosion to the battery shelf or tray. On occasion this has resulted in earthing (a "short"), causing blackening of the battery container and smoke.

Based on the testing carried out, GS Yuasa determined that the FR material used solely on SWL1100FR with a date code starting 22120728 until 24051428 is susceptible to impact damage. Impact could occur during storage, transit, positioning, handling & installation and can lead to a fissure even with no other evidence of damage to the container.

- Customer Recommended Preventive Action** - At maintenance visits check each battery shelf visually for signs of corrosion and additionally test for earthing by looking for either voltage or continuity between the battery string and the shelf it is placed upon. If any earthing, smoke or blackening is observed, the system should be isolated and reported to your local GS Yuasa contact (see Enquiries section for contact details).
