Fire Safety Strategy Report
for
Maelfa Wellbeing Centre

Reference: S19038801
Issue No: 05

Client Address:	Global Reach, Wing A, 3rd Floor, Celtic Gateway Dunleavy Drive, Cardiff CF11 0SN
Project:	Maelfa Wellbeing Centre

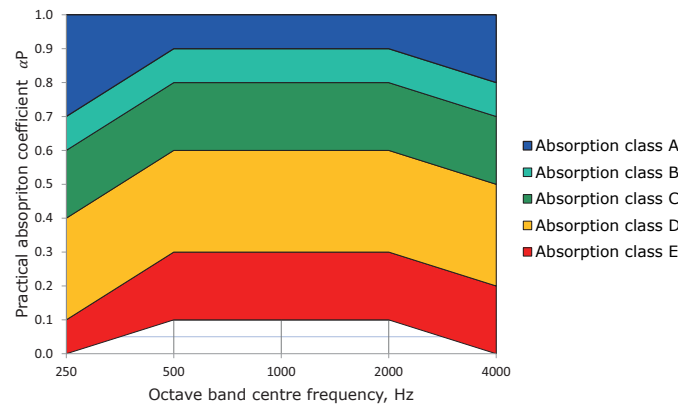
Acoustic absorption performance ranges from Class A (highly absorptive) to Class E (slightly absorptive). The classes are illustrated in Figure 5.

Figure 5 Acoustic absorption classes

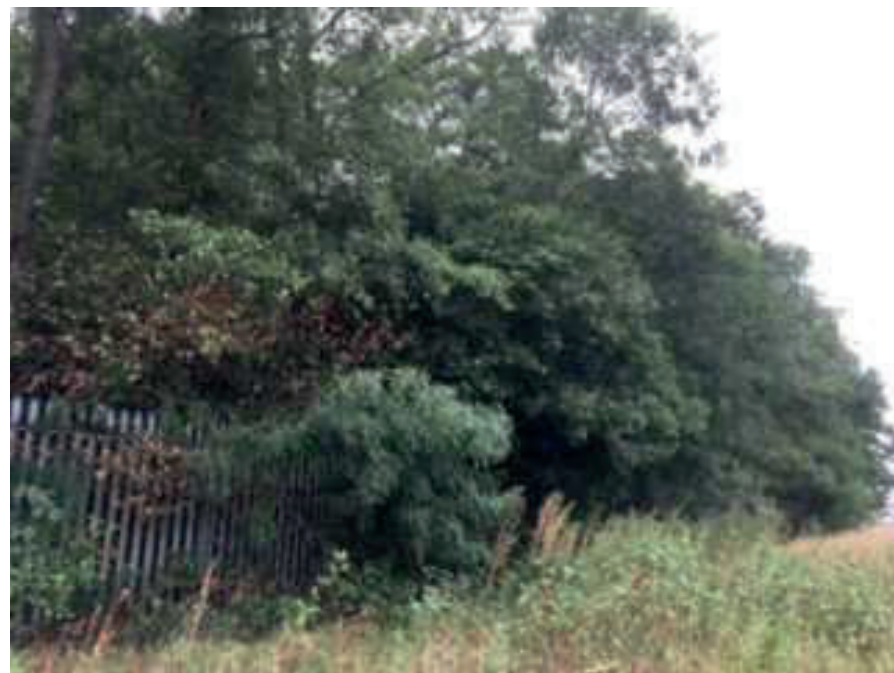
1. Semi-natural broad-leaved woodland is located adjacent to the south of the site and is part of the Llanederyn woodland complex SINC. It is separated from the site by a corrugated metal fence.

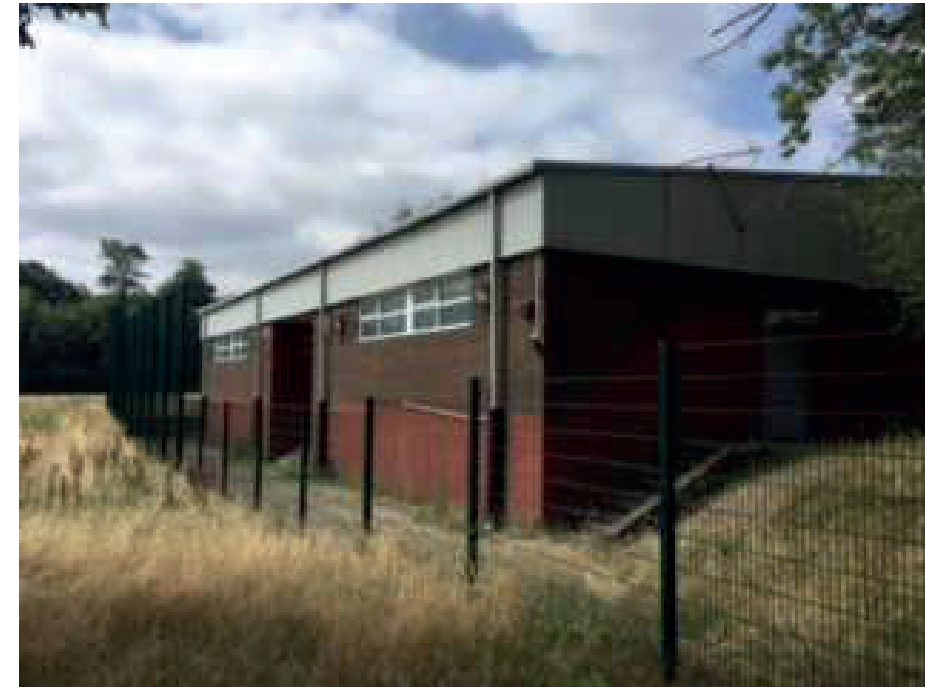
2. A disused, flat-roofed, brick building, previously used as a sports hall. It has fascia board with gaps running along the bottom, there are also additional gaps around the building. It is adjacent to the northern boundary of the site, next to a car park.

x	No potential adverse effects.
<p><u>Building</u></p> <p>There is one building located adjacent to the northern boundary of the site (Please refer to Appendix 1 Target Notes – Target Note 2 and Appendix 4 Preliminary Roost Assessment Results).</p>

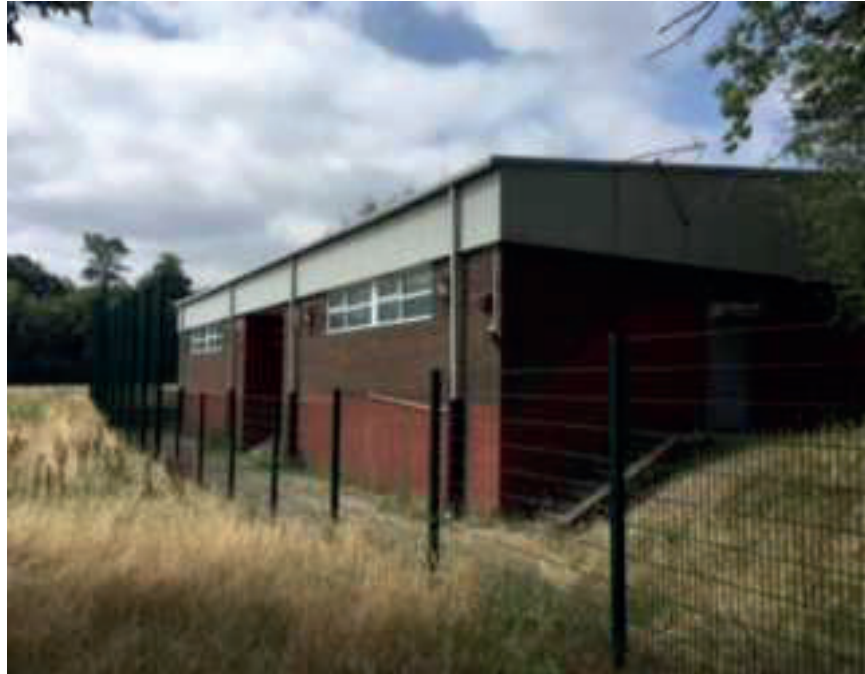
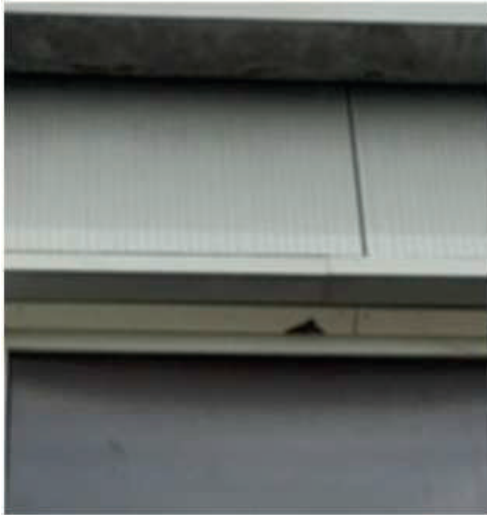
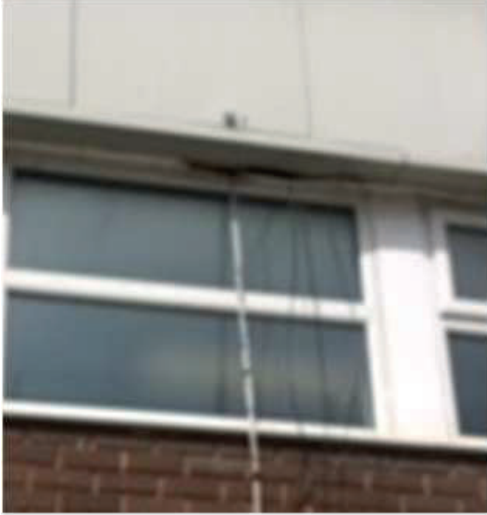
Appendix 4: Preliminary Roost Assessment Results		
Description	Photograph	Potential
<p>Single-storey flat-roofed, brick building, previously used as a sports hall.</p> <p>Gaps are present along several upper window ledges, below the fascia board, particularly along the southern aspect of the building. There is also a longer, larger gap along the eastern aspect with wires hanging out.</p>

<p>Moderate</p>

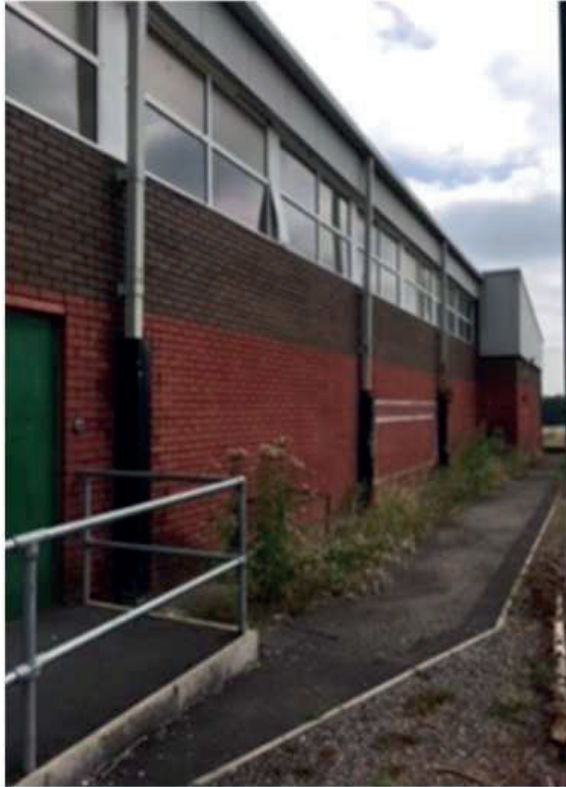
Appendix 4: Preliminary Roost Assessment Results		
Description	Photograph	Potential
<p>On all sides of the building a small gap is present between the fascia board and the roof. On the western aspect there is also a small gap between the fascia board and the brick building.</p> <p>There is a window, on the southern aspect of the building, where a white plastic board has come away, this has created a void.</p>

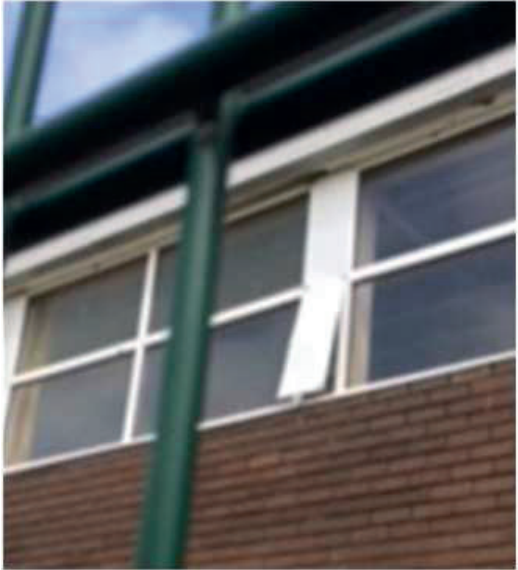
Appendix 4: Preliminary Roost Assessment Results		
Description	Photograph	Potential
<p>There are three air vents present on the southern aspect of the building.</p>

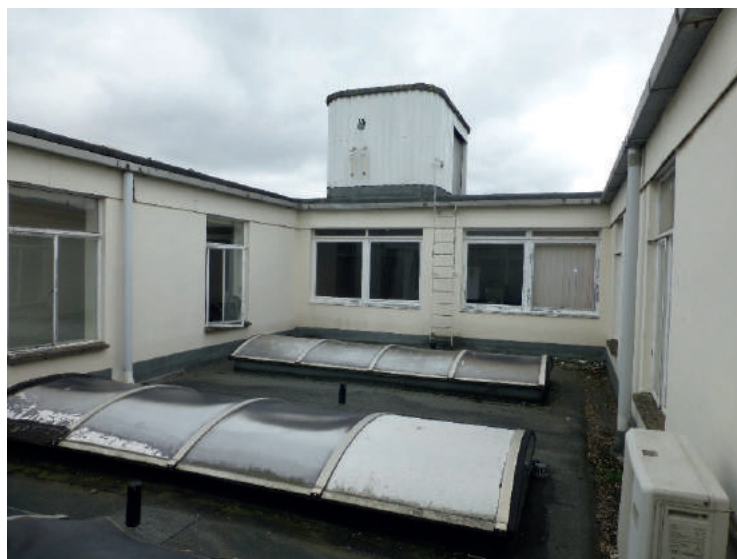
Plate 1 Enclosed single-storey building section with wooden fascia boards at the top of each wall

- 3.1.6 There was a narrow gap extending upwards approximately 30cm between the fascia and the wall with an opening at the bottom. The opening and gap were approximately 4cm wide above the recessed windows but much narrower (less than 1cm) where the fascia adjoins the wall.
