Estates and Facilities Alert

Swimming pool overhead lighting systems

Reference: EFA/2017/001 Issued: 31 January 2017 Valid to: 31 January 2023

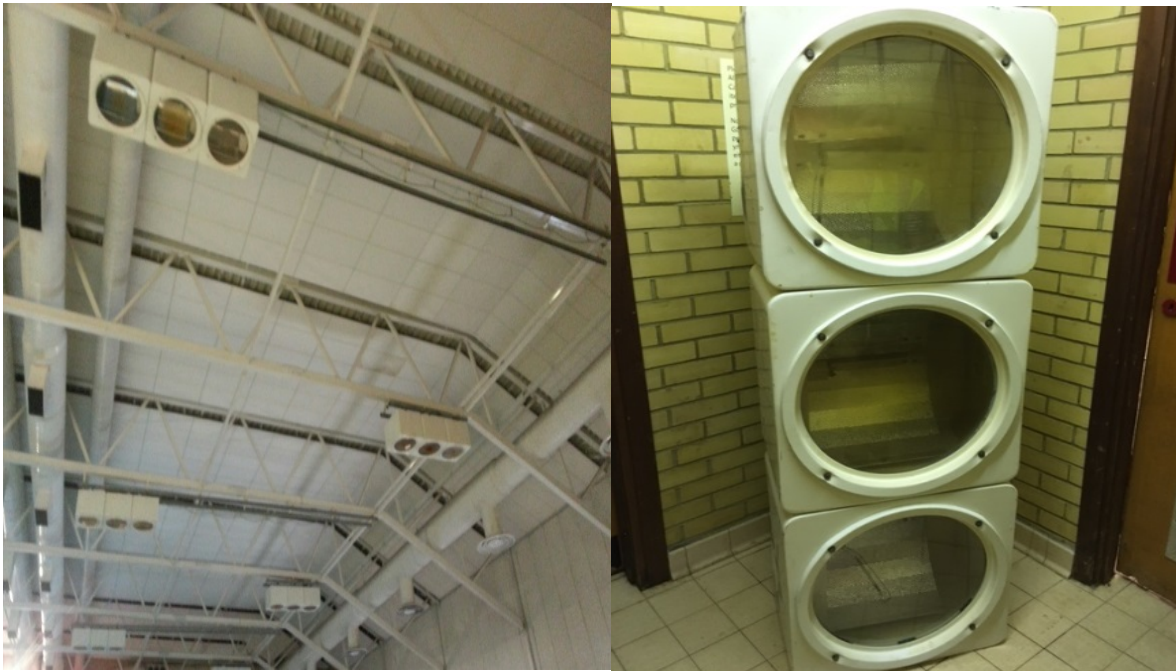
Photo 1 & 2 – Lights in situ at one Leisure Centre Pool and unit that collapsed

Two leisure centre swimming pools were built in South Wales in 1987 and 1989 with square aluminium lighting units that were connected together in a series of three lights. These were then mounted onto runners supported from the ceiling structure. The lights were mains powered and fitted with sodium lamps. The dimensions of the set of three lights together are 1800mm (length) x 600mm (width) x 400mm (depth). Details of the manufacturer have not been fully established. Photographs 1 & 2 show the lighting in situ at one of the leisure centre pool sites and the lighting unit that collapsed.

- Identify whether similar lighting systems are found within your premises. Please see the original HSE alert <http://www.hse.gov.uk/safetybulletins/pool-hall-lighting.htm> to assist with the identification of potential affected units.
- Identify whether the lighting units are attached to the supporting structure / runner by means of a plastic bracket / roller (and the integrity of this is relied upon to support the lighting).
- Carry out thorough inspection of the condition of the plastic bracket / roller where similar designed plastic brackets / rollers are found to be present and, where age or condition gives cause for concern, consider replacement of the brackets / rollers or fitting additional securing mechanisms where appropriate.

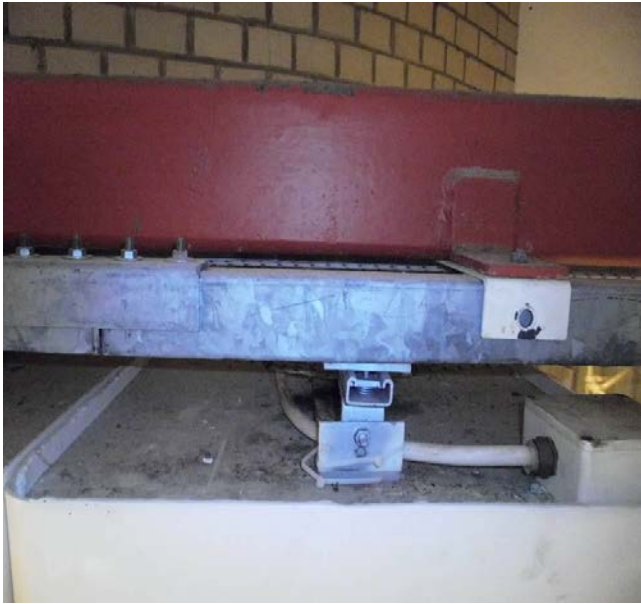
Photo 3 – View of roller and light attachment in situ

Inspection of the lights took place in September 2013 and the condition of the plastic brackets / rollers was not identified as being an issue at that time. However, inspection of the lights in situ would allow very limited visual inspection of the brackets owing to them being located in the metal roller channel. Photograph 3 shows the view any inspection would have of the bracket / roller arrangement when in situ for this particular type of lighting.

Location of plastic bracket / roller – hidden by runner channel fixed to ceiling structure (thin section visible)

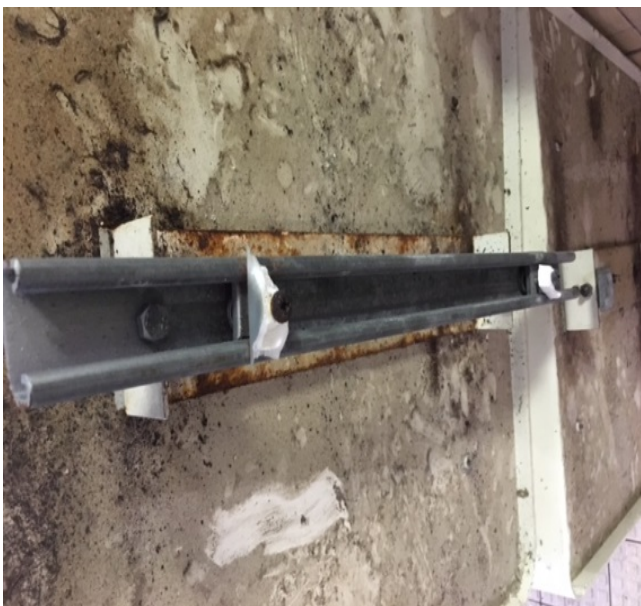
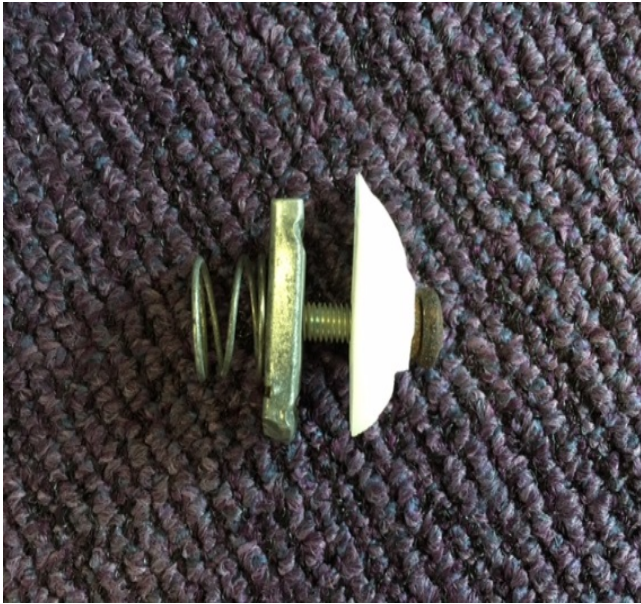
Photos 4 and 5 – Broken Plastic bracket / roller attached to lighting unit

A swimming pool overhead lighting system collapsed without warning and could have caused serious injury to pool users. Certain types of aluminium pool hall lighting systems operate on runners. The lights are attached by means of a plastic bracket / roller that are difficult to observe when in situ. Inspection of the plastic brackets / rollers at two separate swimming pool sites following the incident found severe

degradation / perishing of the plastic on many of the lights found. All of the lights have had to be replaced.

The plastic bracket / roller is secured to a metal profile attached to the lights using a steel bolt and square plate. The bolts showed signs of rusting that may have contributed to the degradation of the plastic bracket / roller. The bracket / roller supports the weight of the three aluminium lighting units which are joined together. The set of three lighting units, which are secured together, were supported by six bracket / rollers (two brackets / rollers per individual light unit). Photographs 4 and 5 show a broken plastic bracket / roller that was attached to the lighting unit.

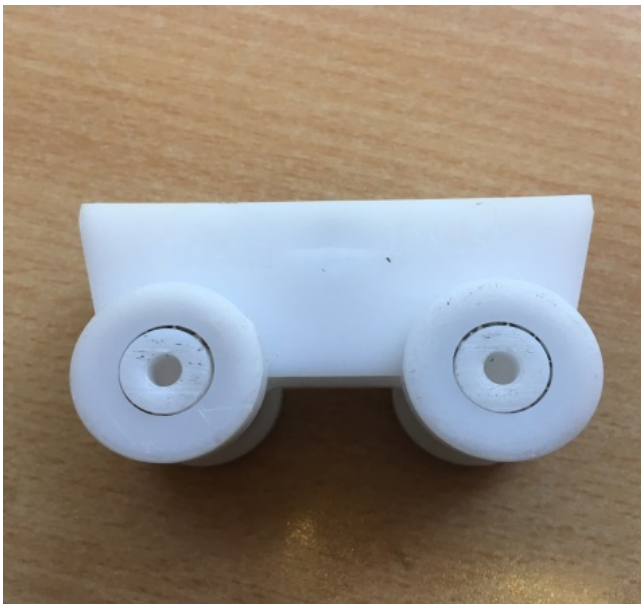
Photo 6 – Complete bracket / roller (without steel bolt and plate)

Photograph 6 shows a complete plastic bracket / roller that was removed from another lighting unit. Please note that the wheels will be positioned at the top within the runner channel fixed to the ceiling structure.

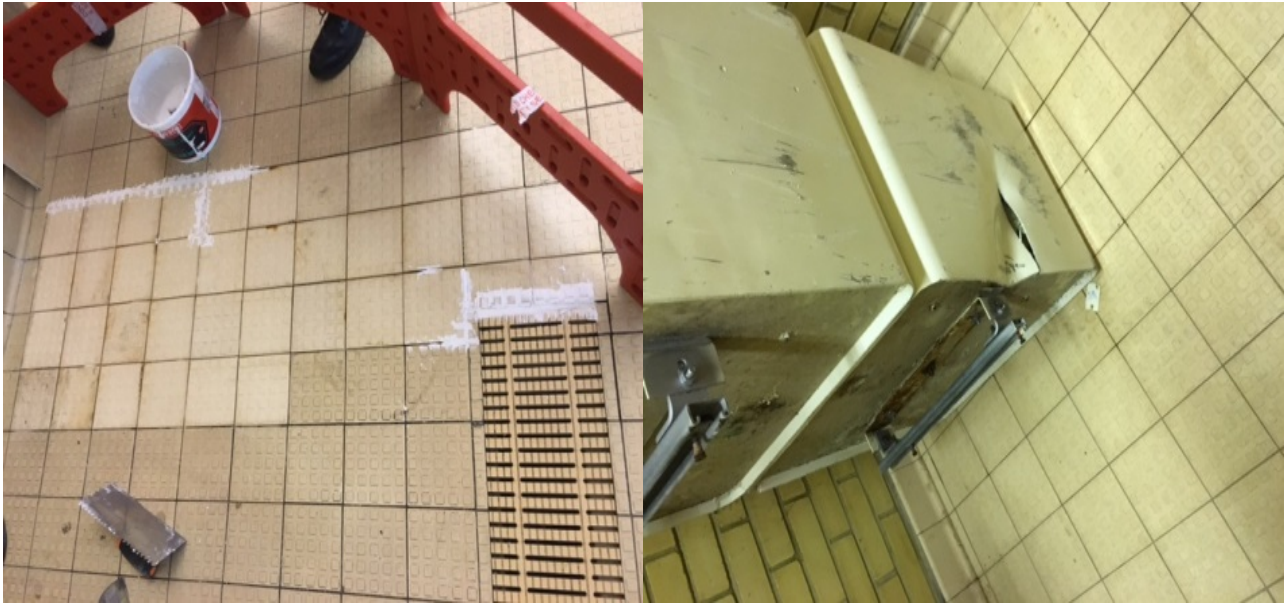
Photos 7 and 8 – Replacement tiles following impact and damaged light unit

During a public swimming session where approximately 10 swimmers were using the pool, a set of lighting units fell to the deck surrounding the pool. Fortunately, nobody was stood next to the pool at the time as the collapse could have caused serious injuries. Photographs 7 and 8 show the area of tiles that were replaced and the damage to the lighting units involved.
