Estates and Facilities Alert

Fire in multi-storey car parks (MSCPs)

Reference: EFA/2018/003 Issued: 02 July 2018 Review Date: 02 July 2024

Fire in Multi-Storey Car Parks

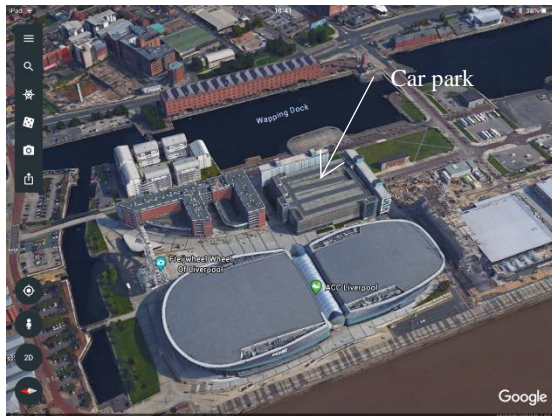
Figure 1: Car Park and adjacent buildings. Image from Google Earth.

The car park is shown in Figure 1 and is about 25m away from the Liverpool Echo Arena. Much closer to the car park (separated by approximately 5m) are two apartment blocks, at the top and the right of the image, and to the left is a hotel. All were occupied. The audience were assembling for the final evening performance of The Liverpool Horse Show and the car park was almost full when fire broke out in a vehicle on the third floor. This was observed and photographed by a member of the public.

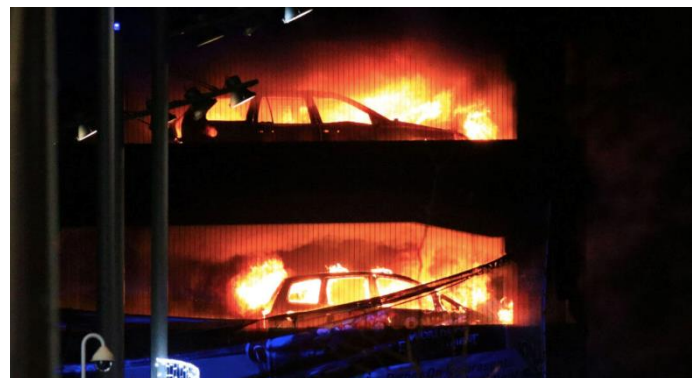
Figure 2: Fire on separate levels. Image courtesy of Liverpool Fire and Rescue Services (MFRS).

Merseyside Fire and Rescue Services arrived within a few minutes by which time the fire had spread to several adjacent cars. Some cars were abandoned on the ramps and the occupants left through the protected staircase towers. Firefighters attacked the blaze from within the third floor but were unable to stop its spread both horizontally and vertically. Figure 2 shows cars burning simultaneously on two levels. As well as extinguishing the fire, firefighters' attention turned to the critical task of saving the adjacent buildings. Merseyside Fire and Rescue Services had 12 appliances (pumps), 3 combined platform ladders (CPLs) and 3 high volume pumps (HVPs) in attendance. The fire was prevented from spreading to adjacent buildings and was put out after several hours. There were no casualties, and no complete collapse so the event is classed as a near-miss in both life-safety and structural terms.

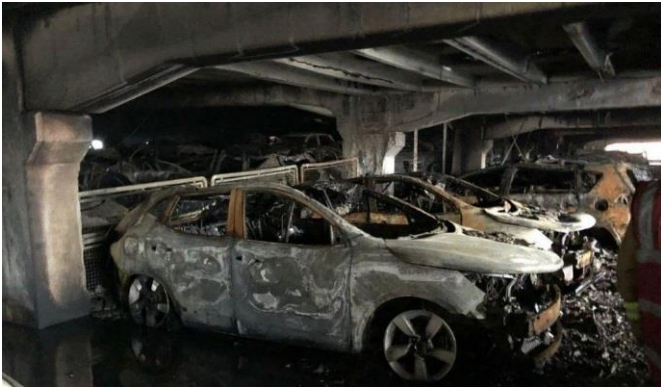
Figure 3: The scale of devastation. Image courtesy of MFRS.

The car park was built in 2006 as part of the development of the Liverpool Echo Arena on land adjacent to the River Mersey. Overall size is approximately 70m x 60m with columns at about 7m centres in the shorter direction. There are four spans of beams in the longer direction and there are four concrete stair and service cores with fire doors onto the parking floors. As can be seen from the photograph in Figure 3, the columns and beams are substantial. Between the beams and spanning about 7m are precast ribbed floors and these have totally disintegrated down the middle of some floors and partially collapsed in other places as shown in Figure 4.

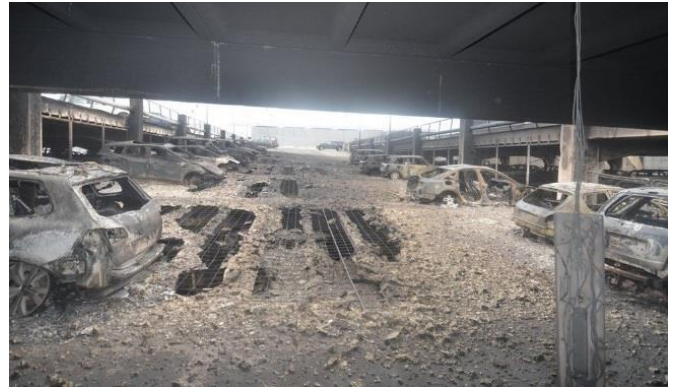
Figure 4: Disintegration of floor slab. Image courtesy of MFRS.

The floors, however, were too dangerous to enter. A photographic survey using a specialised drone was therefore carried out. It was flown along the floors from the stair core lobbies and much information was obtained. The material will be incorporated in the forensic investigation reports.
